**Larimer County Road 27 (Buckhorn Road) along Buckhorn Creek
September 2013 Flood Recovery, Larimer County, Colorado**

ANDERSON CONSULTING ENGINEERS, INC.
Civil • Water Resources • Environmental

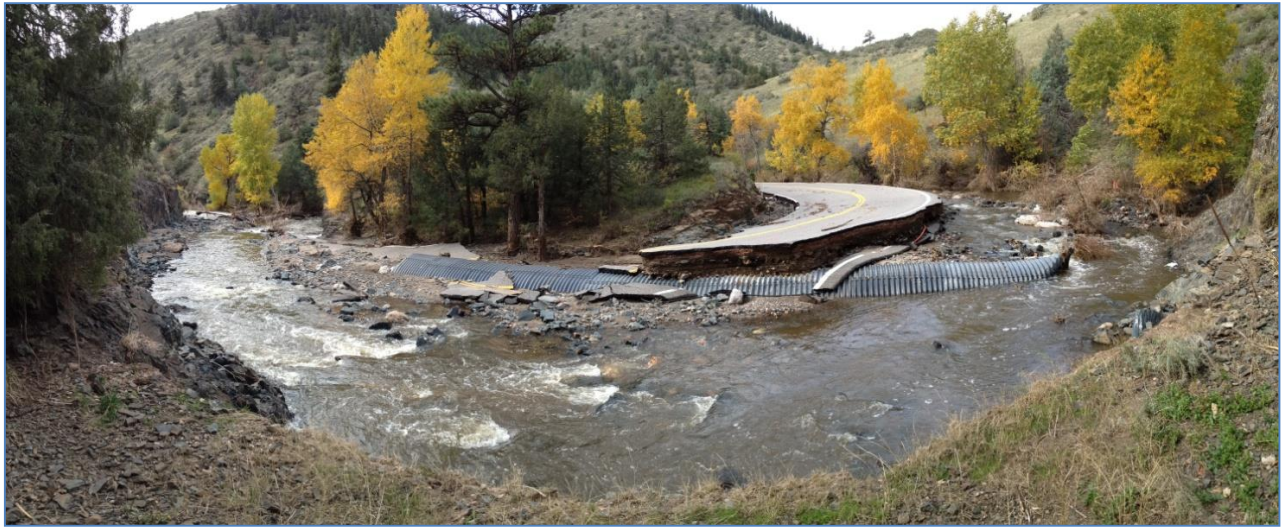
The Narrows of Larimer County Road 27 and Buckhorn Creek – Post-flood (October 2013)

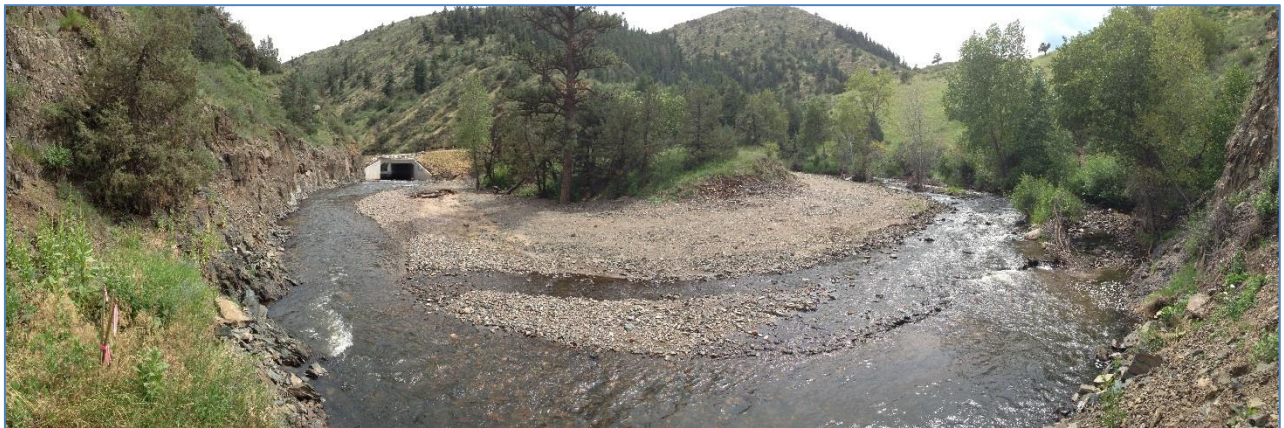
The Narrows of Larimer County Road 27 and Buckhorn Creek – Post-construction (July 2015)
