**High Park Fire Area Flood Mitigation Support – Mill Creek
Larimer County, Colorado**

Client: Mr. Mark Peterson, P.E.
Larimer County
Engineering Department
P.O. Box 1190
Fort Collins, CO 80521
(970) 498-5714

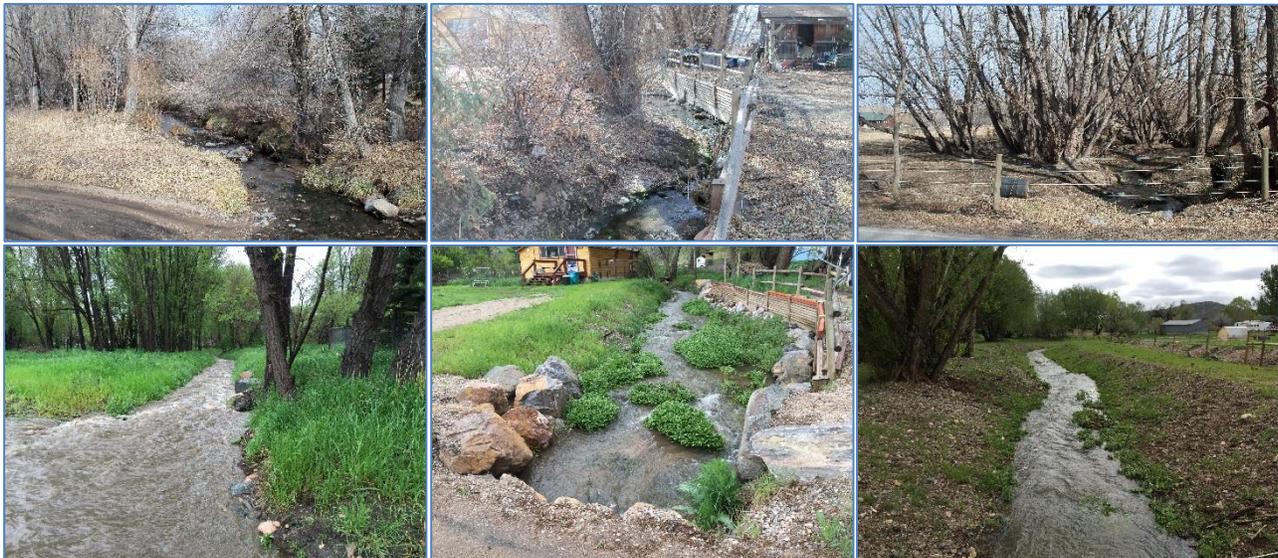
Mill Creek – Pre- and Post-Construction

ACE **analyzed the hydraulics and sediment transport** of the Mill Creek system through Bellvue, and **developed design for: a new culvert crossing** for LCR 23, **channel restoration and stabilization** for Mill Creek between 2nd Avenue and 1500-feet downstream of LCR 23, **grade control** to prevent downcutting for the highly erodible reach between 2nd Avenue and LCR 23, a **sediment forebay** to collect the high sediment load associated with the post-fire Mill Creek watershed, **erosion countermeasure design** at the new culvert and other critical areas, and **revegetation** of the project.
