**High Park Fire Area Flood Mitigation Support – Rist Canyon and Empire Gulch
Larimer County, Colorado**

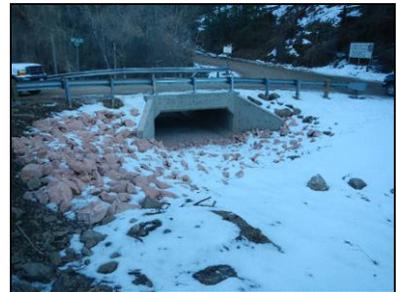
Whale Rock Road – Rist Canyon

For Rist Canyon in Larimer County, eight crossings of Larimer County Road 52E (LCR 52E) were determined to be insufficient for conveying anticipated post-fire flow events. ACE **analyzed the hydraulics** associated with a 25-year flow event to **design upgrades to the existing culvert infrastructure** and to **design erosion countermeasures** for the new culvert crossings.

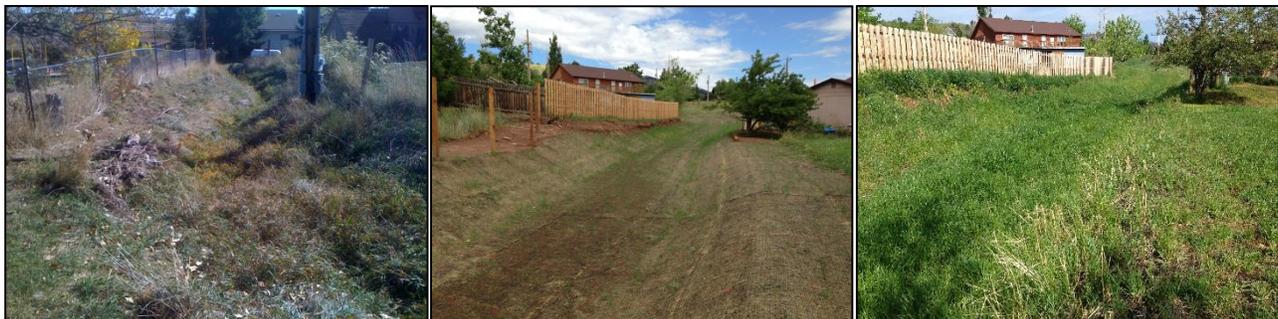
Empire Gulch – Pre- and Post-Construction

Empire Gulch conveys flow through the Mill Canyon Estates subdivision in Larimer County. Following the High Park Fire, residences to the north of the gulch experienced flooding as a result of increased post-High Park Fire flow events and an undersized channel. ACE **analyzed the hydraulics** associated with the 100-year post-High Park Fire flow event to **design an improved channel** capable of safely conveying flood flows through the subdivision.
